Cologne Cathedral Scaffolding Removal Proves Challenging

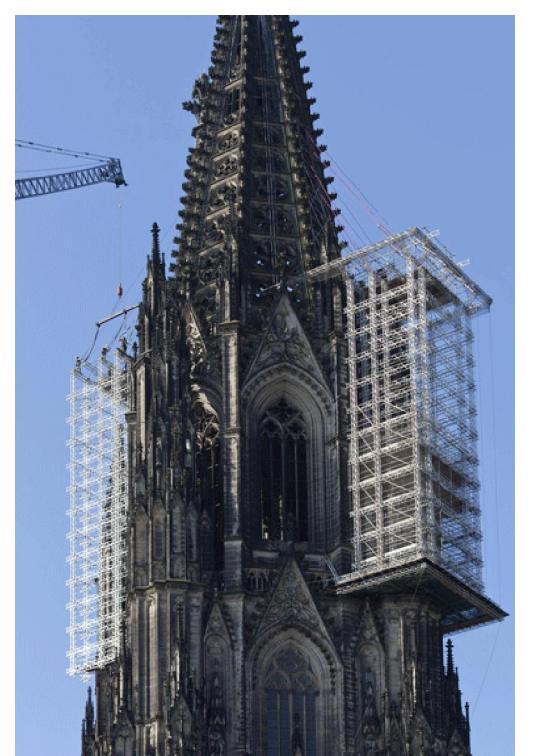
Dismantling two hanging scaffold structures from the north tower of Cologne Cathedral in Germany may seem fairly straightforward but presented several challenges. To carry out the lifts with the crane erected on the station forecourt at Cologne Central Train Station meant the operators could only assemble the boom at night.

One of the scaffold structures was at a height of 100 meters. To carry out the tasks, a Liebherr LTM 1750-9.1 configured with a maximum hook height of 154 meters was used.

One of the largest pieces of scaffolding was removed in three sections, according to a company spokesperson. Once the sections were separated, the LTM 1750-9.1 was able to lift the scaffold off the cathedral. The sections

measured 7 meters wide and 33 meters high. In total, the task took four hours.

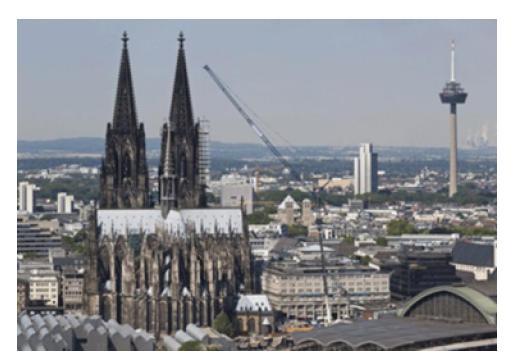
During the lifts the scaffold sections were lifted between the cathedral towers and positioned in front of the main entrance of the cathedral. A Liebherr LTM 1070-4.2 helped with the final positioning of the sections.
